EXPLANATION

FOR: AMI

RAPID SERVICE UPDATE: CONTROL UNDER STEERING WHEEL

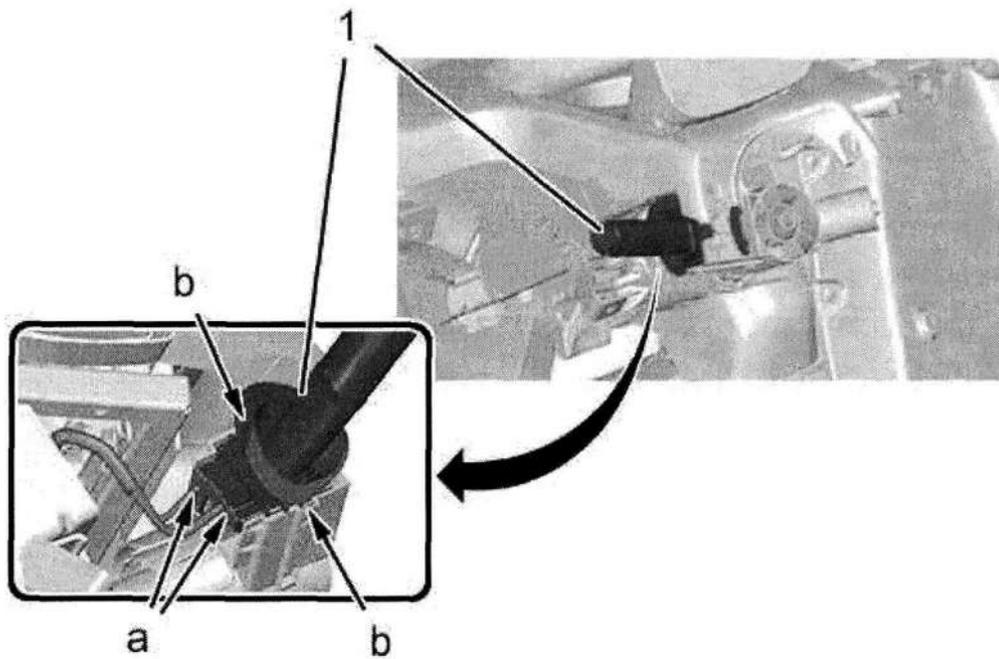
Disconnect the connectors (At "a") .

Unclip (At "b") .

Remove the steering wheel control (1) .

Reconnect the connectors (at "a") .

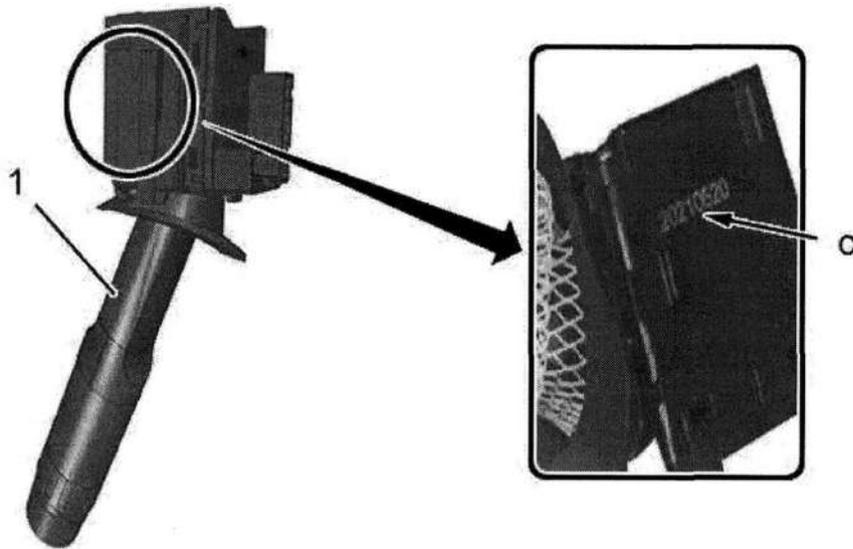
"c" Supplier's date of manufacture : Example "20210620"

(1) Control under the steering wheel .

Check the manufacture date (at "c") •

If the date of manufacture is earlier than "20200927" ; The vehicle does not conform ;
Carry out repair

If the date of manufacture is "20200927" or later ; The vehicle conforms ; Carry out
the additional operations

Refit the new control under the steering wheel (1); Reclip (At "b") .
