## MULTIMEDIA DISPLAY: REMOVAL - REFITTING

## 1 - MULTIMEDIA DISPLAY: REMOVAL - REFITTING

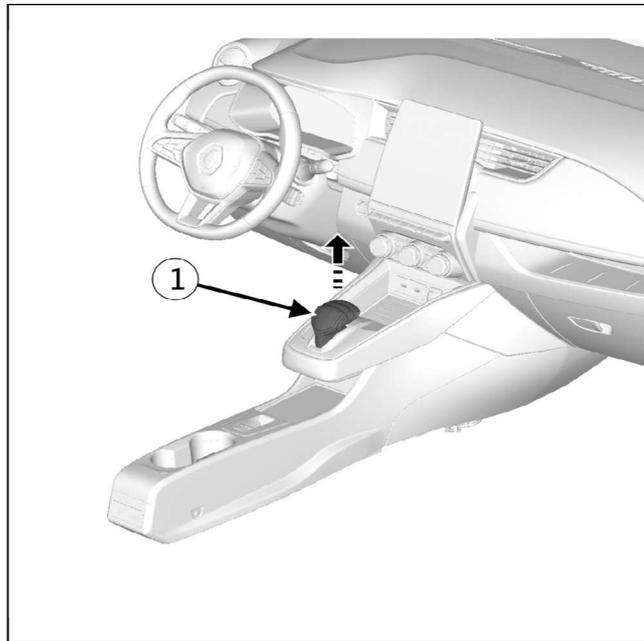
RPR-001044296-01-000263622

- Remove the automatic gearbox control knob (1) in the direction indicated by the arrow (see, gear lever knob : removal - refitting) .

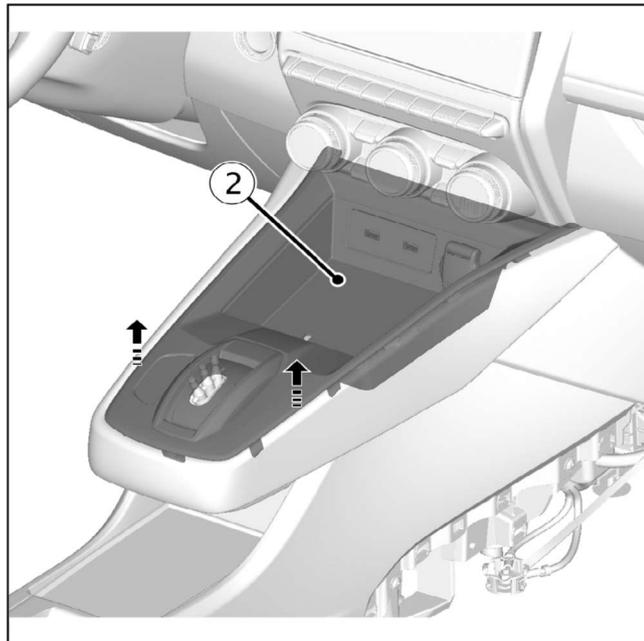
RPR-001044296-04-000263628

- Remove the gear lever trim (2) from the centre console in the direction of the arrow using the (Car.1363) .

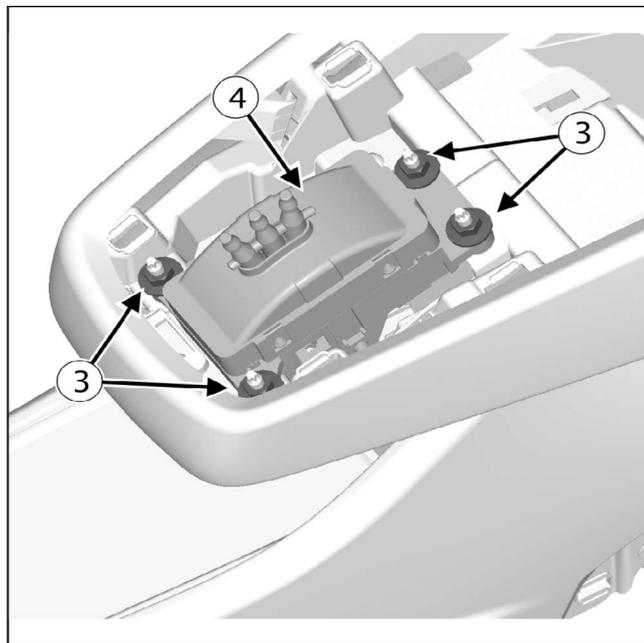
RPR-001044296-05-000263630

- Remove the bolts (3) .
- Take out the gearbox control unit (4) .
- Disconnect its connector.

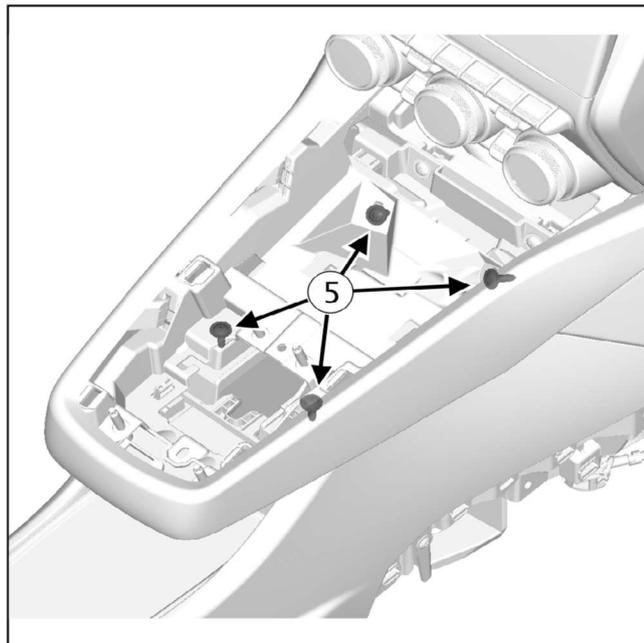
RPR-001044296-06-000263632

- Remove the bolts (5) .

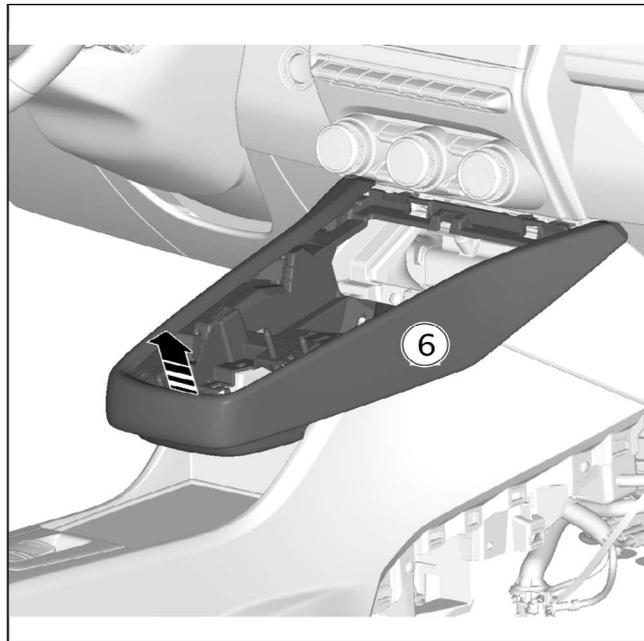
RPR-001044296-09-000263634

- Remove the console upper front panel (6) in the direction of the arrow.
- Unclip the wiring.

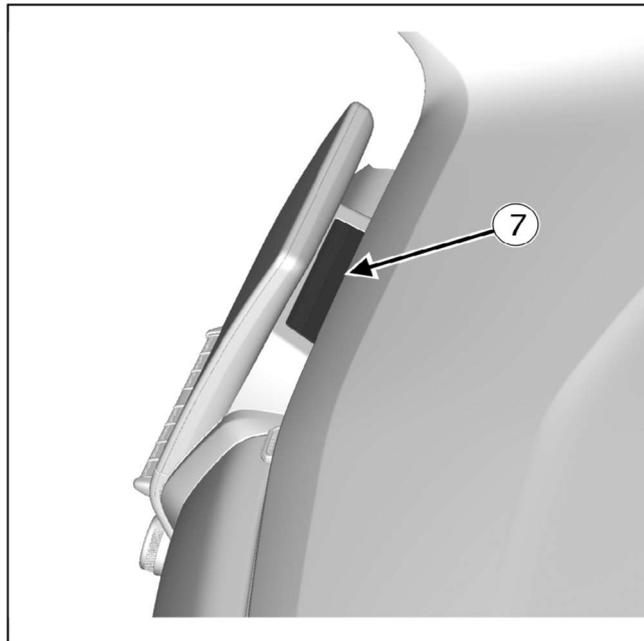
RPR-001044296-08-000221587

- Remove the trim (7) using the (Car.1363) .

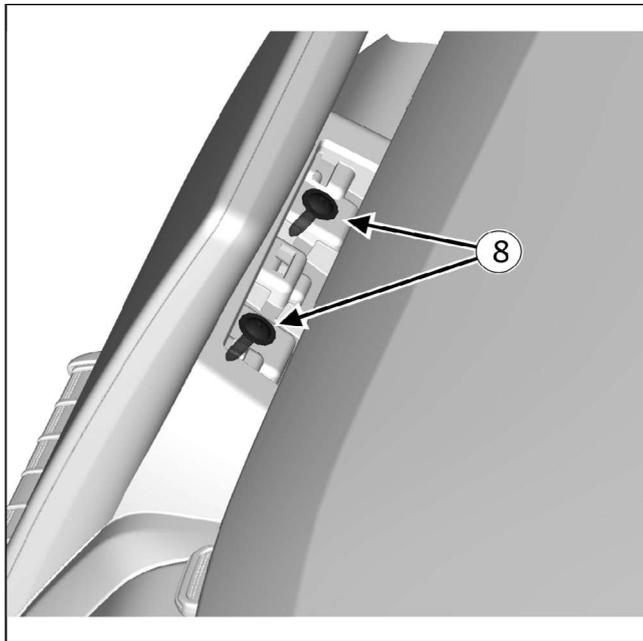
RPR-001044296-07-000221589

- Remove the bolts (8) .

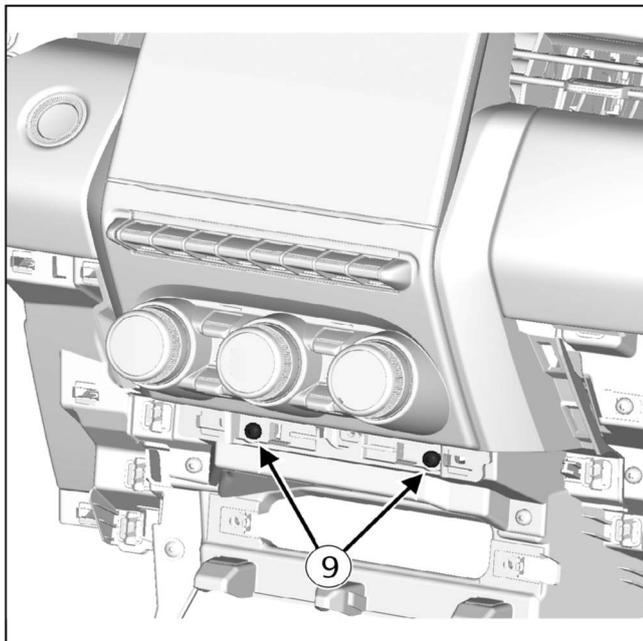
RPR-001044296-10-000221871

- Remove the bolts (9) .

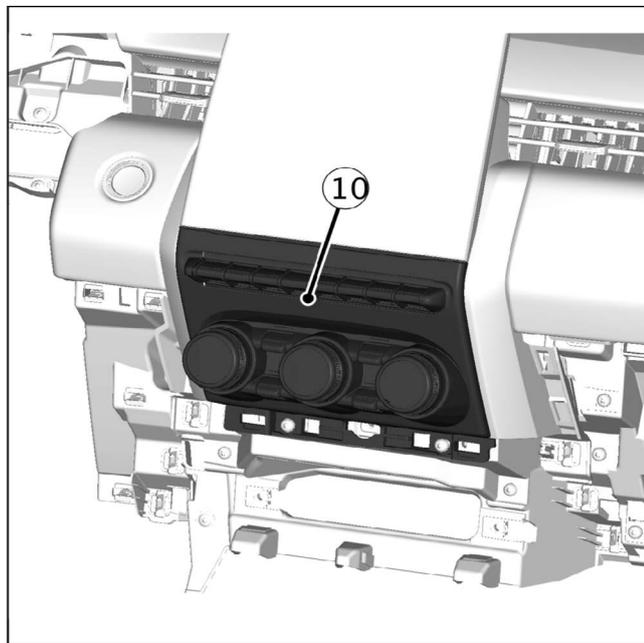
RPR-001044296-11-000221585

- Remove the piano bar control and air conditioning control plate assembly (10) ,
- Disconnect:
  - the piano bar,
  - the air conditioning control panel.

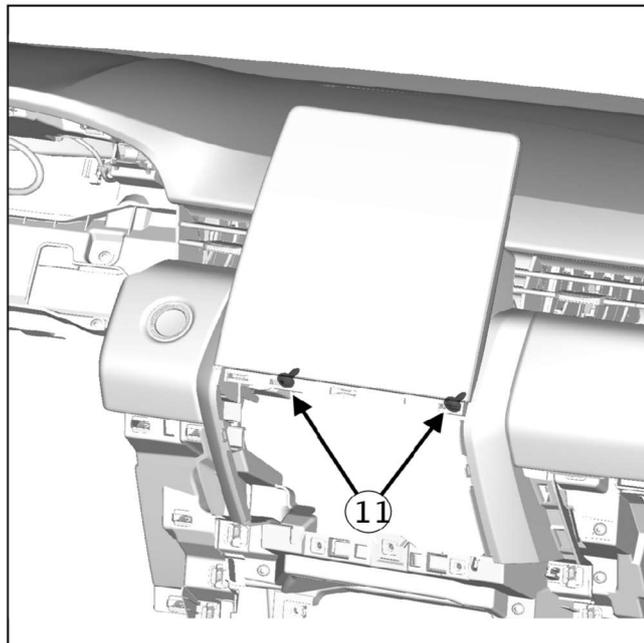
RPR-001044296-12-000221591

- Remove the bolts (11) .

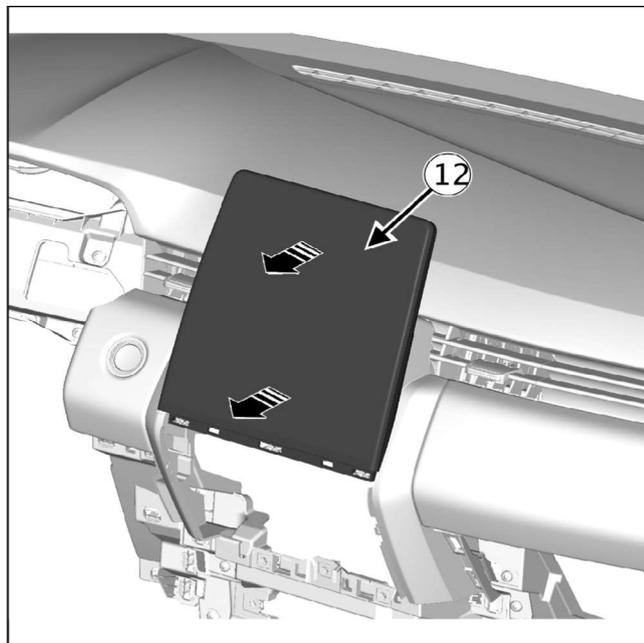
RPR-001044296-13-000221593

- Remove the multimedia display (12) , using the (Car.1363) in the direction indicated by the arrow.
- Disconnect the navigation display connectors.
